OLA FLOOD PLAIN MANAGEMENT STUDY

**YELL COUNTY
ARKANSAS**

JUNE 1984

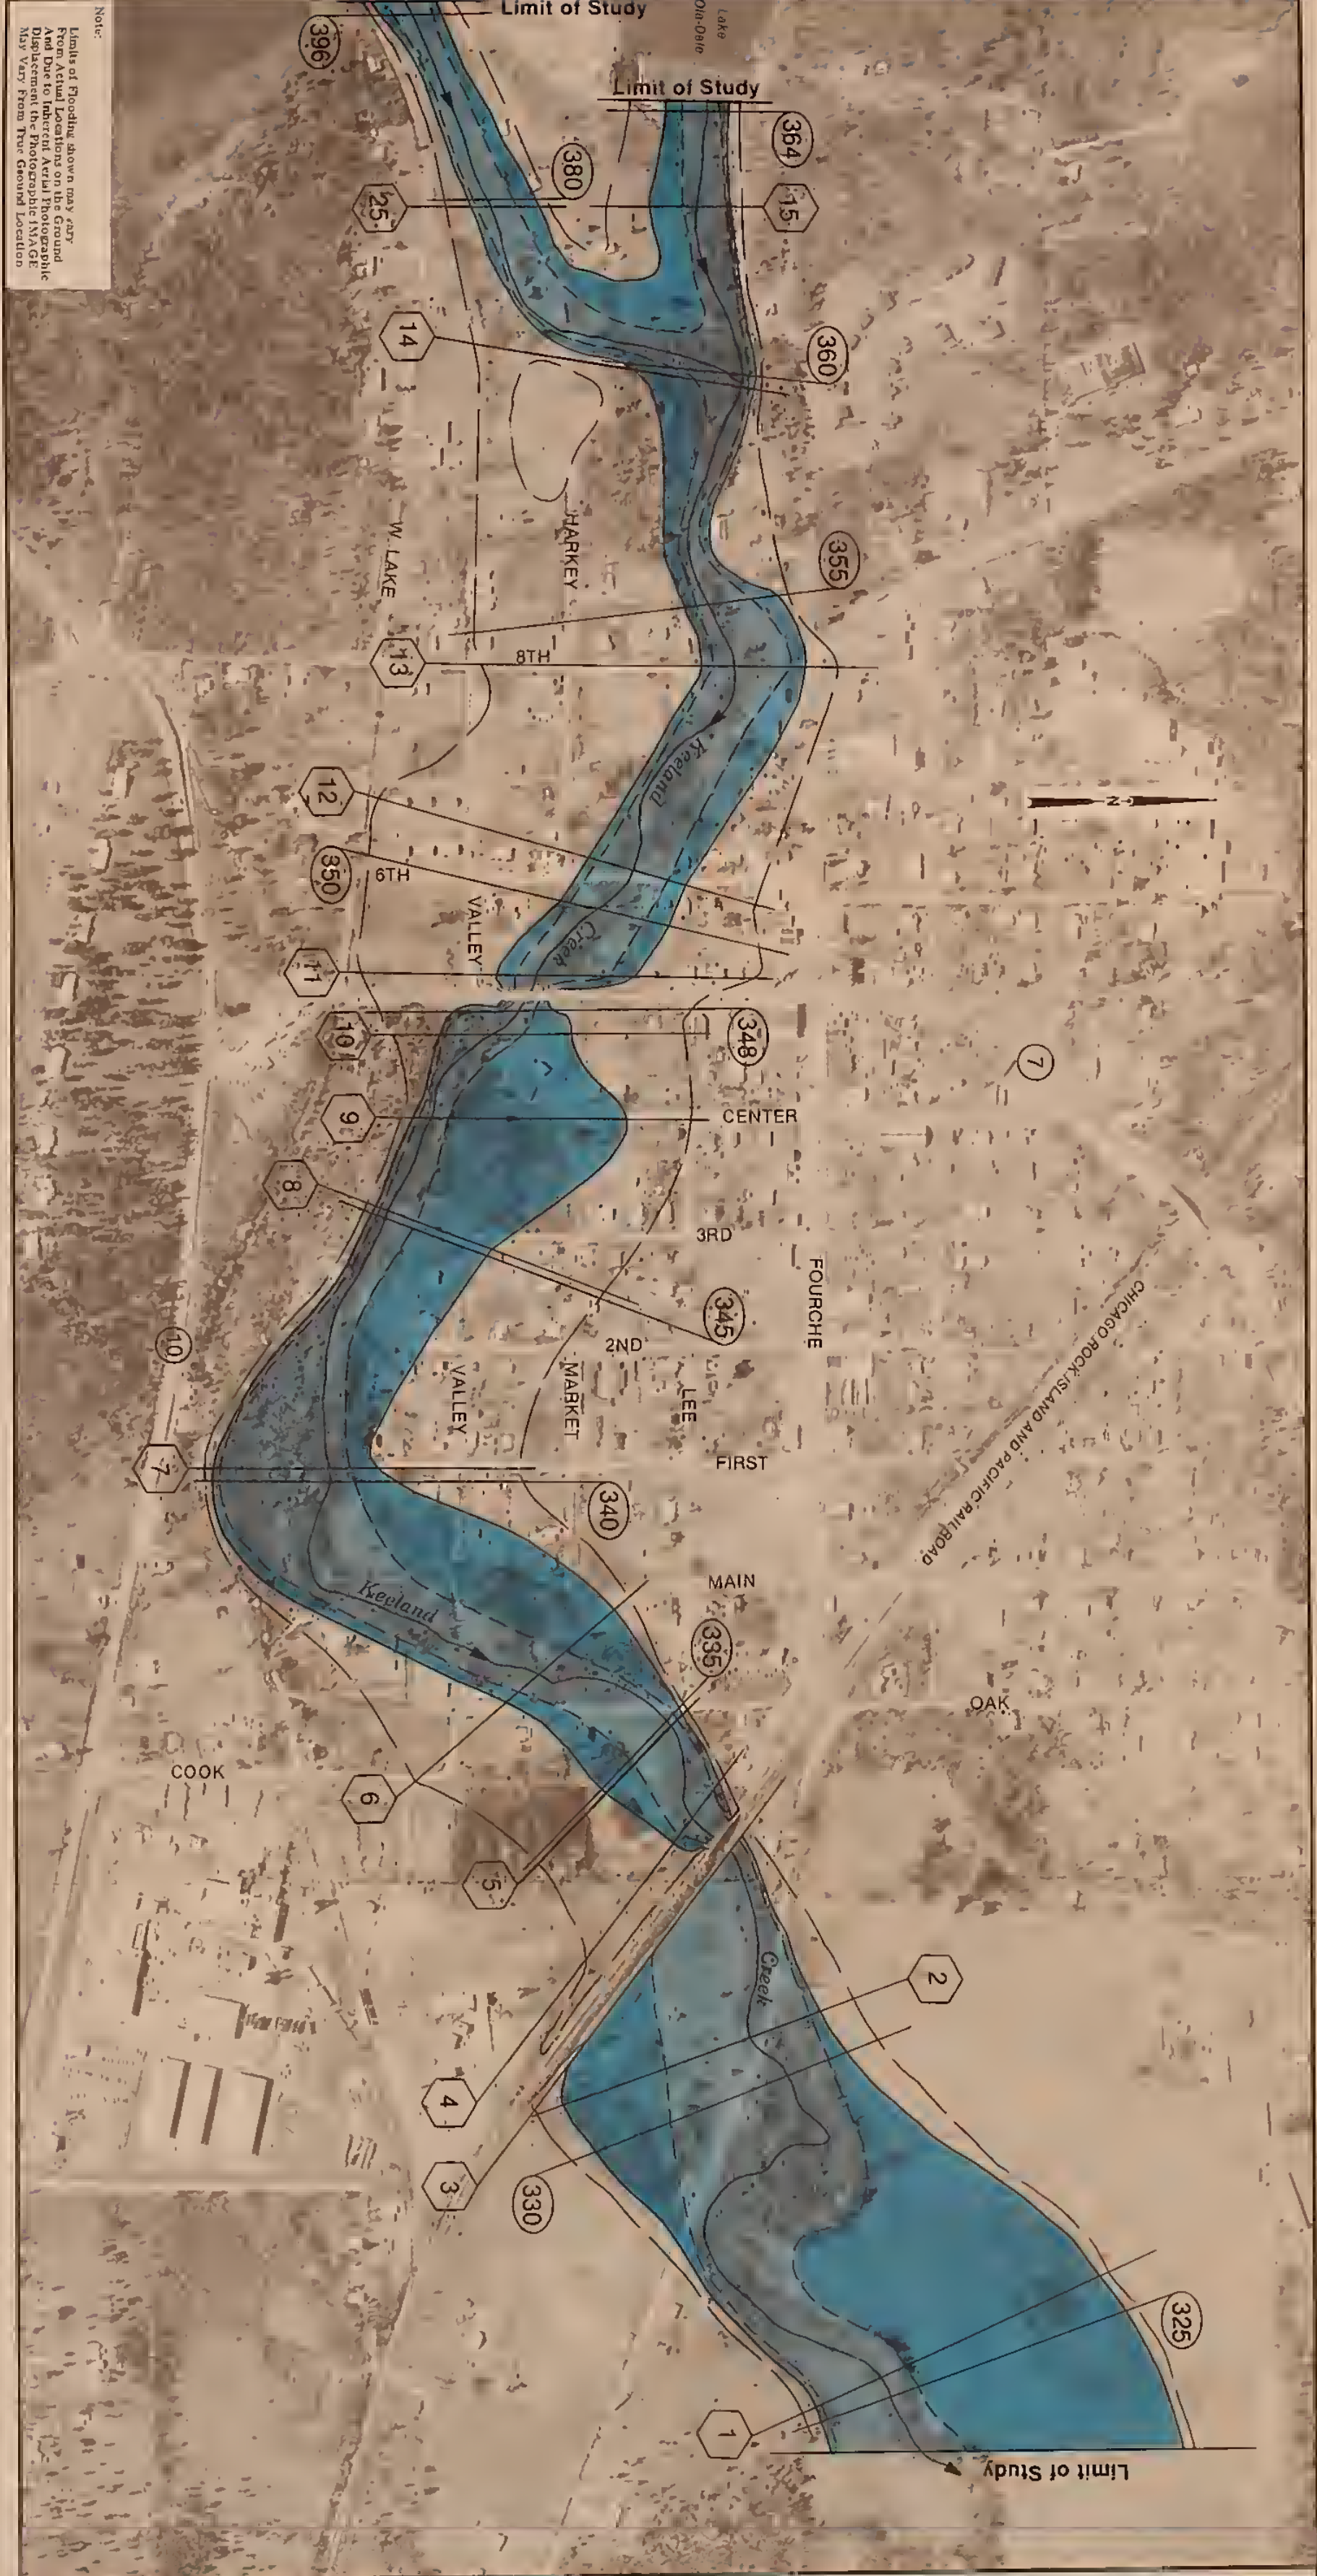
FLOOD HAZARD AREA
KEELAND CREEK

Note:
Limits of Flooding shown may vary
from Actual Locations on the Ground
Due to Inherent Aerial Photographic
Misplacement the Photographic Image
May Vary from True Ground Location

6. Evacuation Plan - The possibility exists that an excessive amount of rainfall or a structural failure could result in the collapse of the dam which was declared hazardous because of inadequate spillway capacity. Should collapse be imminent, it would be necessary that residents below the dam be evacuated in a short period of time. A plan should be developed to monitor the potential for excessive runoff which might cause overtopping of the dam, to regularly inspect the condition of the dam and spillway, to promptly repair any deficiencies revealed during the inspection, and to evacuate residents of the area in the event that failure is likely. The area estimated to be inundated following a dam breach is indicated on the Flood Hazard Area Map.
